## SITE INSPECTION ML 47280

Date: May 31, 2006 Time: 2:30- 3:30

Lease #: O,G & H, ML 47280

Lands Inspected: SW1/4SW1/4NW1/4 and S1/2NW1/4SE1/4 of Section 32, T.5S., R.22E.,

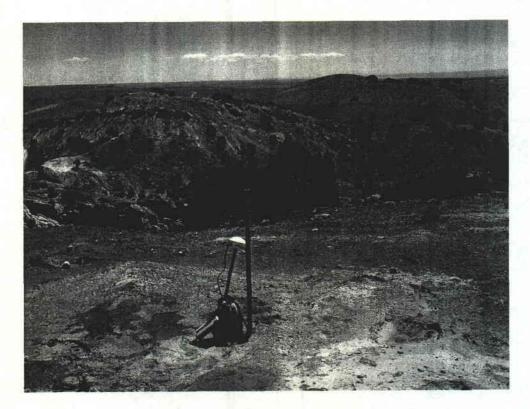
ML 47280 - 5-31-06, Looking south onto a drill hole at UTM coordinates N 4466564.24, E 629267.78. This hole is in a area with numerous roads that is apparently used as an offroad recreation area.

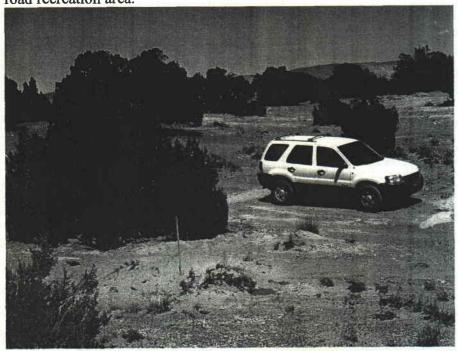
ML 47280 – 5-31-06, Second drill hole found south east of the drill hole shown in the previous picture. UTM coordinates for this hole are: N 4466547.53, E 629368.56.

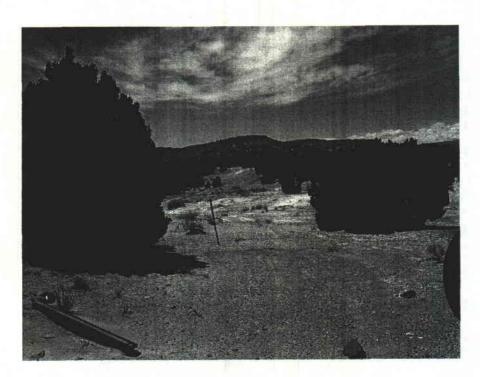
ML 47280 – 5-31-06, Typical survey marker found near the drill hole depicted in the previous picture. Similar survey markers were observed on other lease held by Black Sands Holding Co.

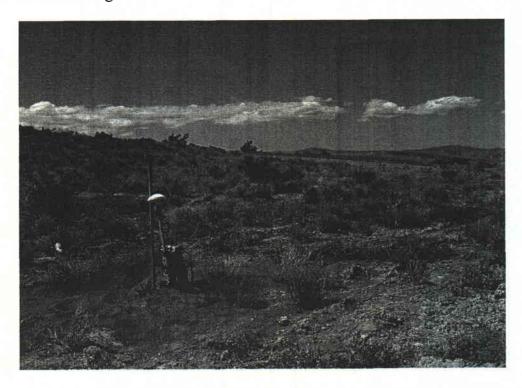
With in the S½NW¼SE¼ one drill hole was observed. This drill hole was covered in the same manner as previously mentioned and was estimated to be approximately 50 to 75 feet deep. All the drill holes observed appear to have been drilled using an 8 to 10 inch rotary-air drill rig as evidence by the diameter of the hole and the cuttings around the drill holes. Drill hole depth was estimated by dropping a stone down the drill hole and observing the time it took to hit the bottom of the hole. GPS- UTM coordinates were taken for the drill hole locations identified in this report.

ML 47280 - 5-31-06, A third drill hole found southeast of the other drill holes. The UTM coordinates for this hole are N 4466174.06, E 630335.07.
